# Kanmantoo Copper Mine Landscape Function Analysis 2022

30 January 2023

## Prepared by EBS Ecology for Hillgrove Resources Limited

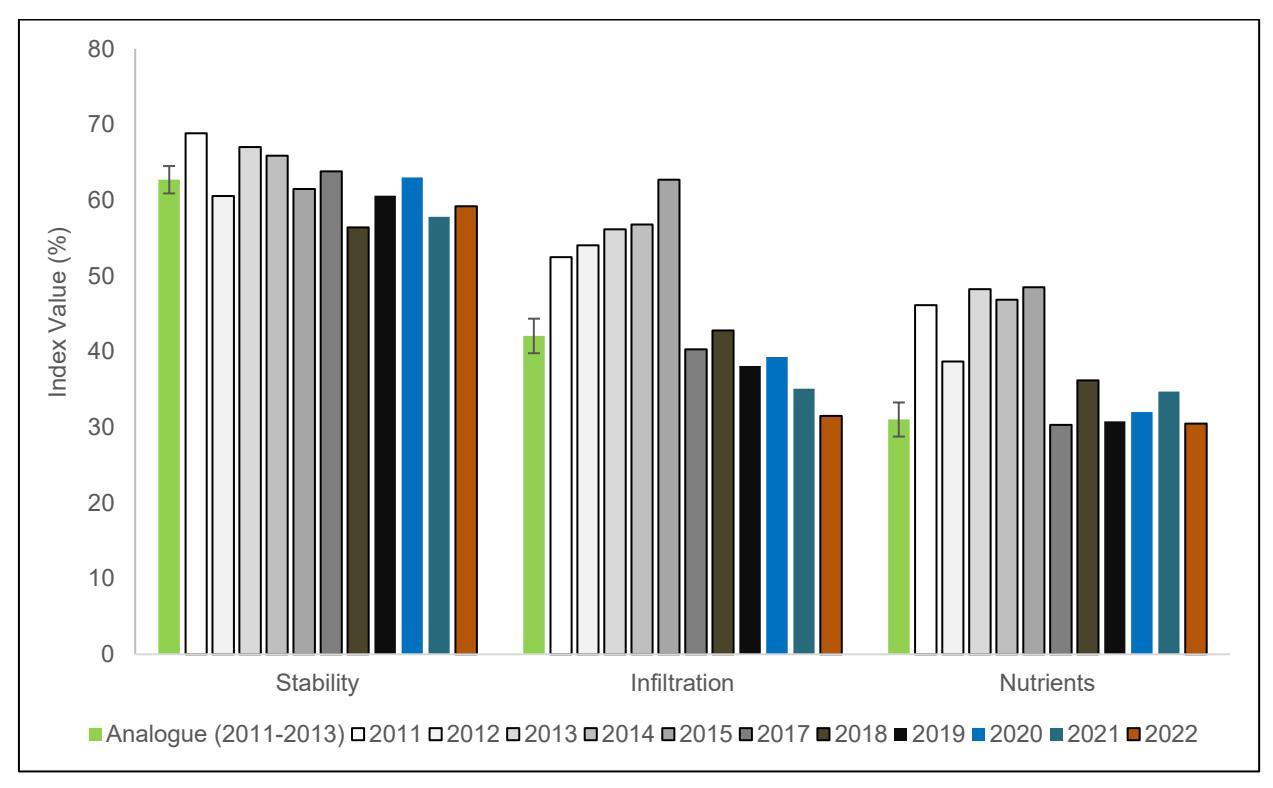
Figure 5. Landscape function indices change (2011-2022) for KANODO 4 with respect to mean analogue site values (2011-2013).

Site KANODO 4 had soil surface indices approaching analogue values (Figure 5) for stability and nutrients but a lower level of infiltration than previous years. Apart from small fluctuations in proportions of Shrub, Tree and Branch Complex patches, the general patch proportions are similar to the previous 3 years of monitoring (Figure 6). Landscape organisation is approaching or exceeding analogue values, with larger average interpatch length compared to the analogue (Table 2). Visually, this site appears to show little change from previous years, including the shrub layer of which individuals have remained small after the removal of corflute tree guards (Appendix 3).

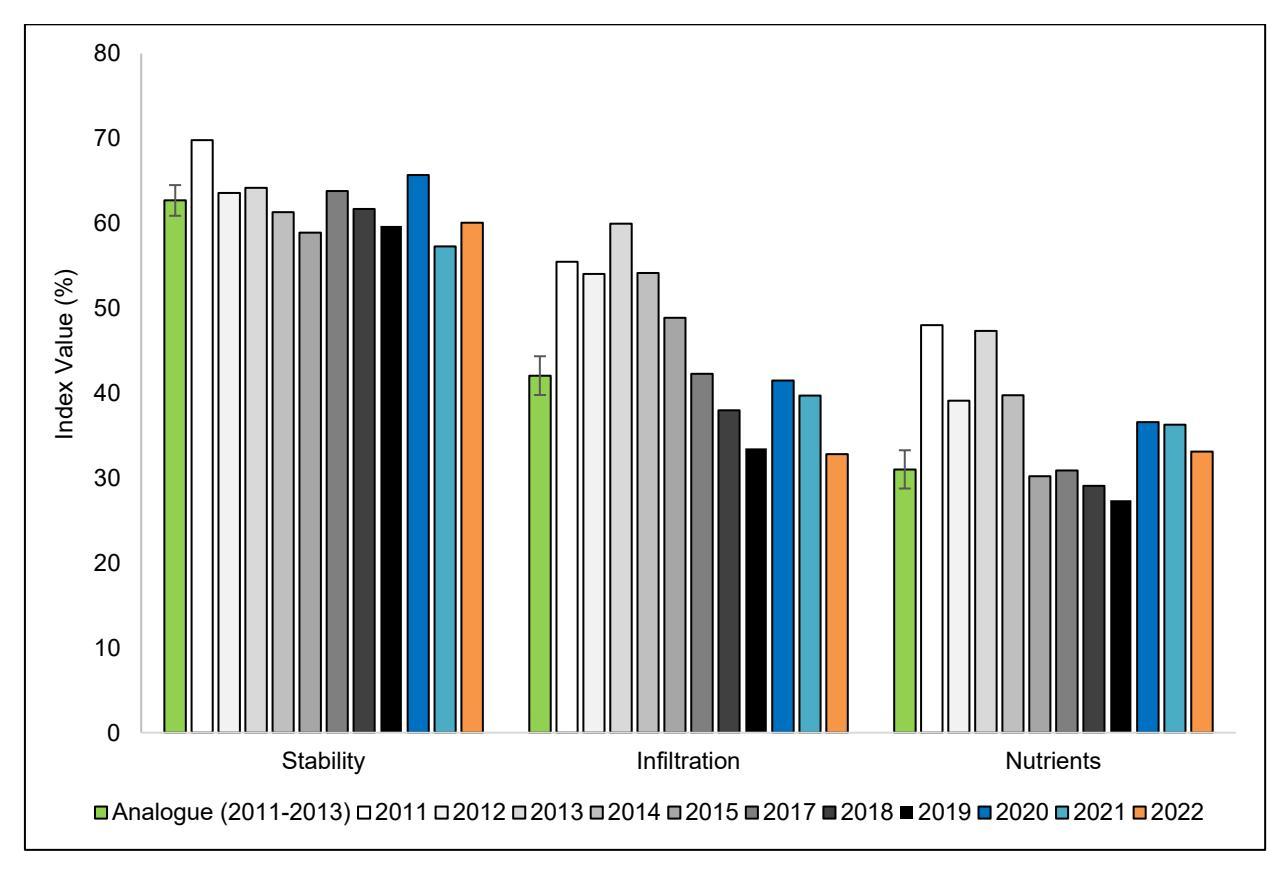
Figure 7. Landscape function indices change (2011-2022) for KANODO 5 with respect to mean analogue site values (2011-2013).

At KANODO 5, stability, infiltration and nutrient indices had similar values to the analogue values after a decreasing trend up until 2019 (Figure 7). Transect proportions indicated a similar complexity to previous years (2018-2021), with a mix of tree patches, shrubs, and branch complexes (Figure 8). These are components that were initially absent in the degraded, unrestored community, however the site remains visually similar to previous years which includes some plants (i.e., *Acacia pycnantha*) remaining small (<u>Appendix 3</u>). The landscape organisation summary data for this site is highly variable over years, with no obvious trends able to be deciphered (Table 3). This may be a result of observer bias.

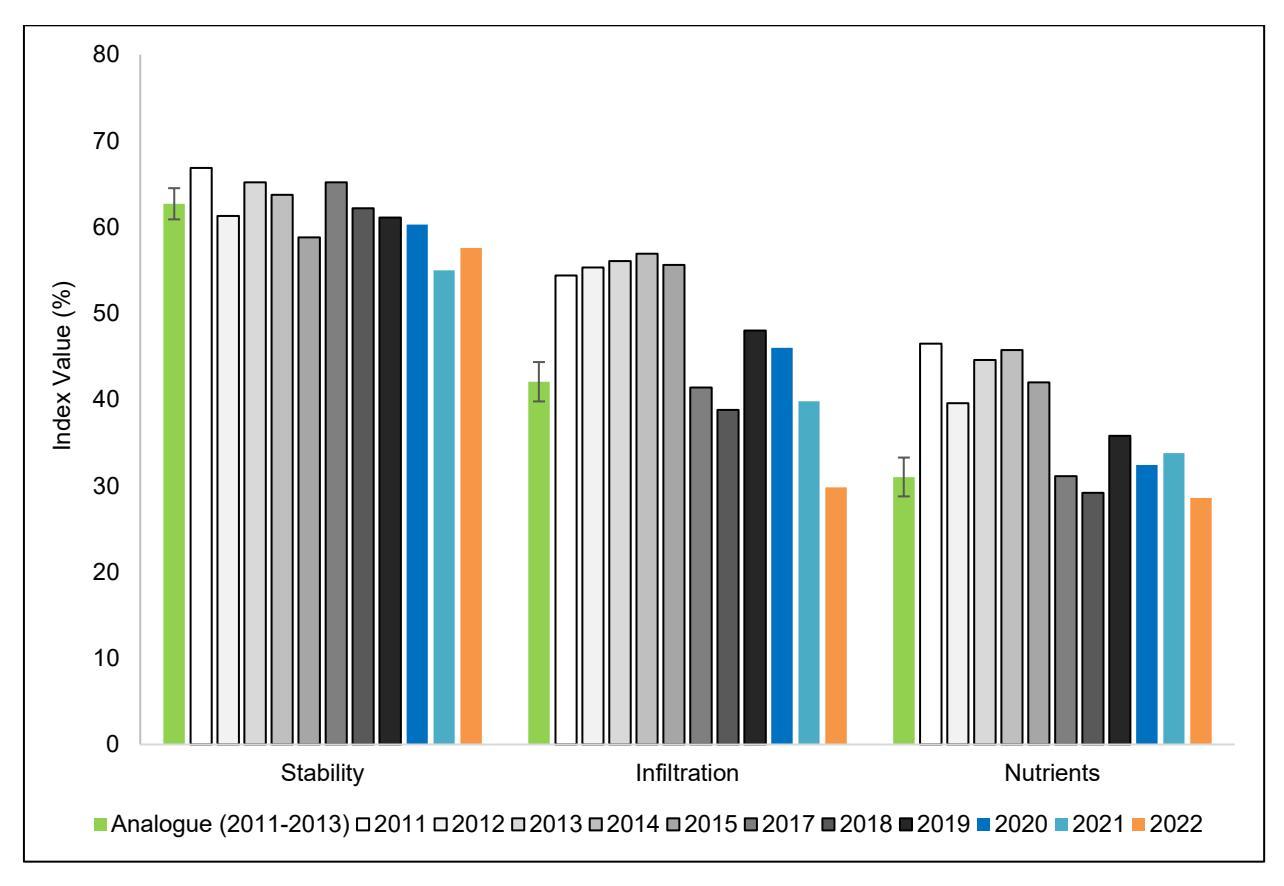
Figure 9. Landscape function indices change (2011-2022) for KANODO 6 with respect to mean analogue site values (2011-2013).

Landscape function values for 2022 at KANODO 6 showed small variability from previous years except for infiltration. Recorded values are similar to analogue values, which demonstrate low rates of change within the remnant communities (Figure 9). Transect proportions show similar complexities to previous years (2017-2022), particularly 2021 with similar shrub and tree patch areas (Figure 10). It is possible that the very high numbers of kangaroos do not allow very rapid recolonisation and establishment of herbaceous species. The Landscape organisational data summary does demonstrate the site is changing towards the analogue values, albeit slowly (Table 4).

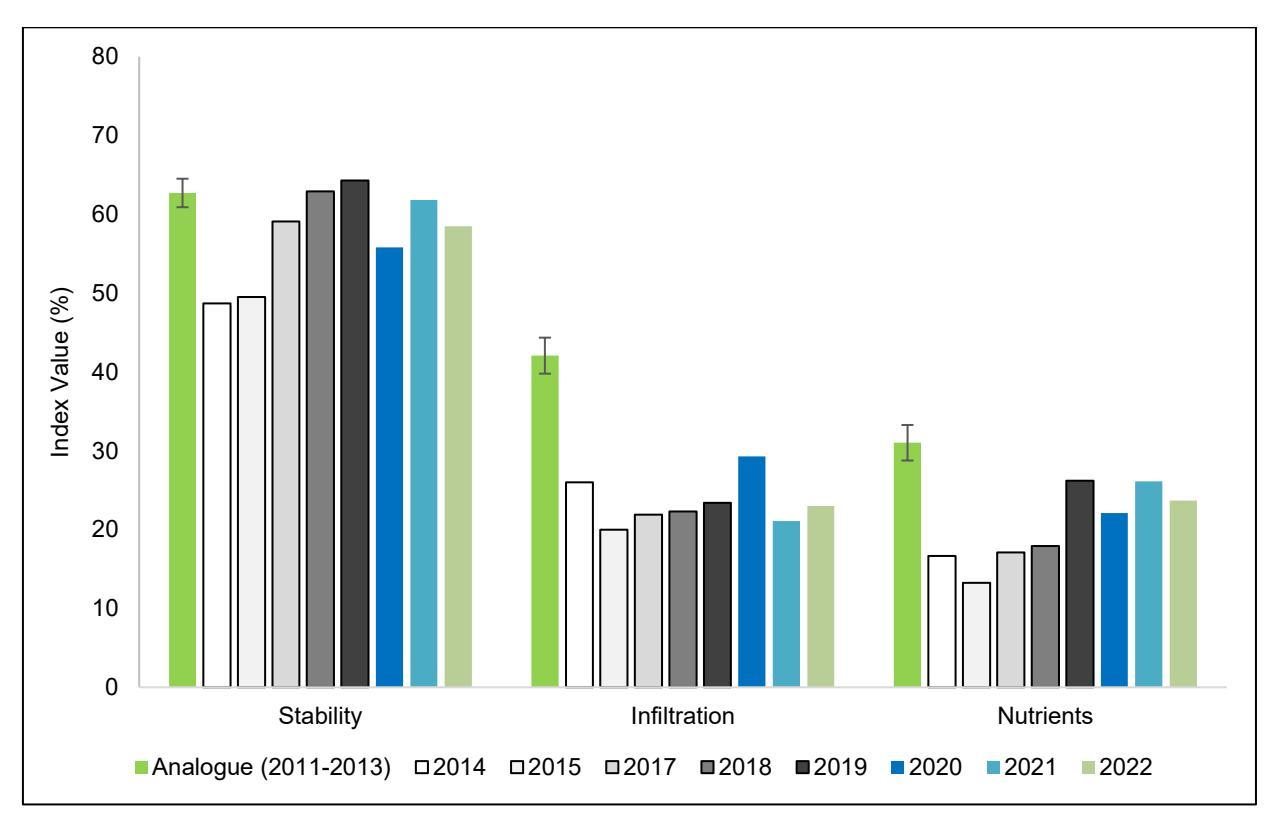
Figure 11. Landscape function indices change (2014-2022) for KANODO 8 with respect to mean analogue site values (2011-2013).

This site has performed well with a transition from an exotic grassland into a moderately complex restored area. The stability, infiltration and nutrient indices are similar to previous years, with stability and nutrients increasing towards the analogue values, but infiltration remains low (Figure 11). The site is maintaining complexity with the presence of shrub patches, grass swards and tree patches (Figure 12). The number of patch zones per 10 m has increased away from the analogue values while the total patch area and interpatch length have decreased from analogue values (Table 5). Visually, the vegetation (predominantly *Acacia pycnantha*) is growing and increasing in size at this site (Appendix 3).

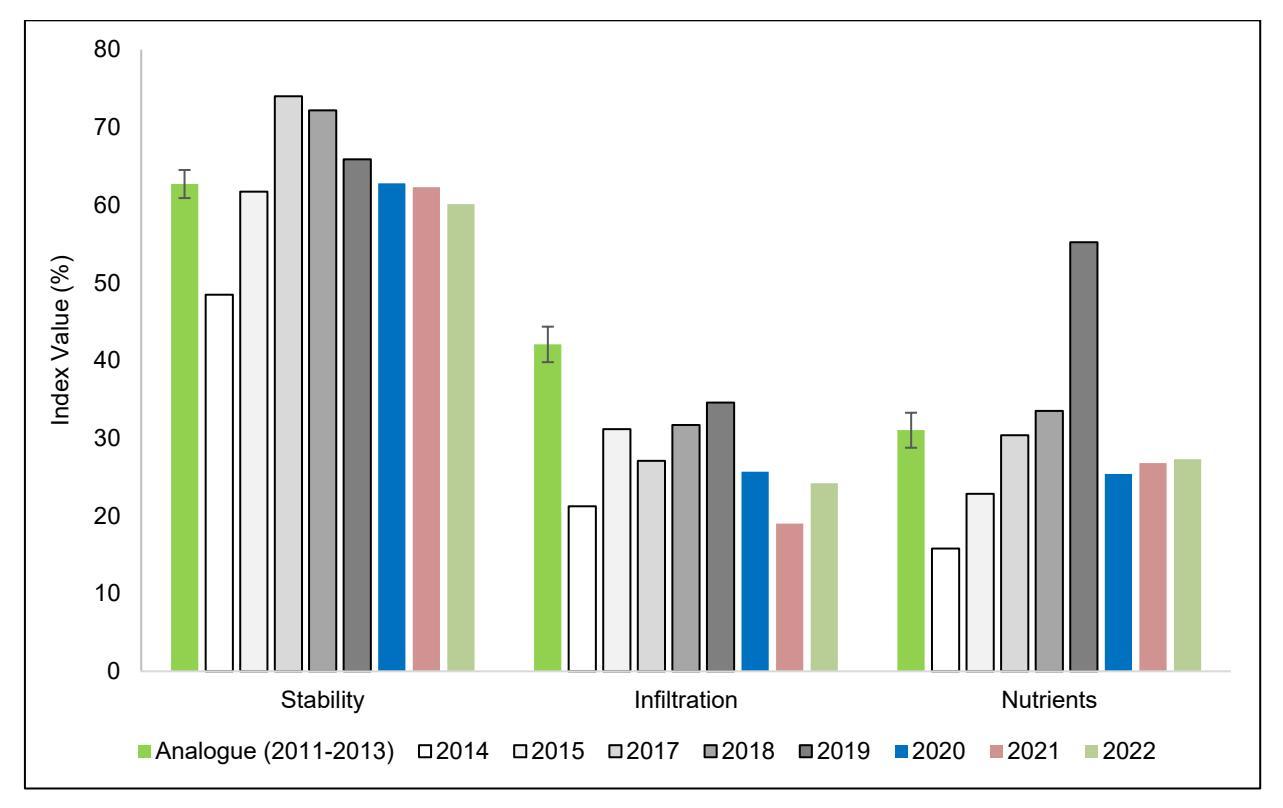
Figure 13. Landscape function indices change (2014-2022) for KANODO 9 with respect to mean analogue site values (2011-2013).

At KANODO 9, the soil stability index has remained similar to analogue values while infiltration and nutrient indices remain lower than analogue values (Figure 13). Proportions of grass swards have continued to decrease compared to all previous years (Figure 14), which is the likely cause for a lower landscape organisational index in the past three surveys years (Table 6). Number of patch zones per 10 m is increasing away from the analogue, while all other landscape organisation data is decreasing below analogue values.

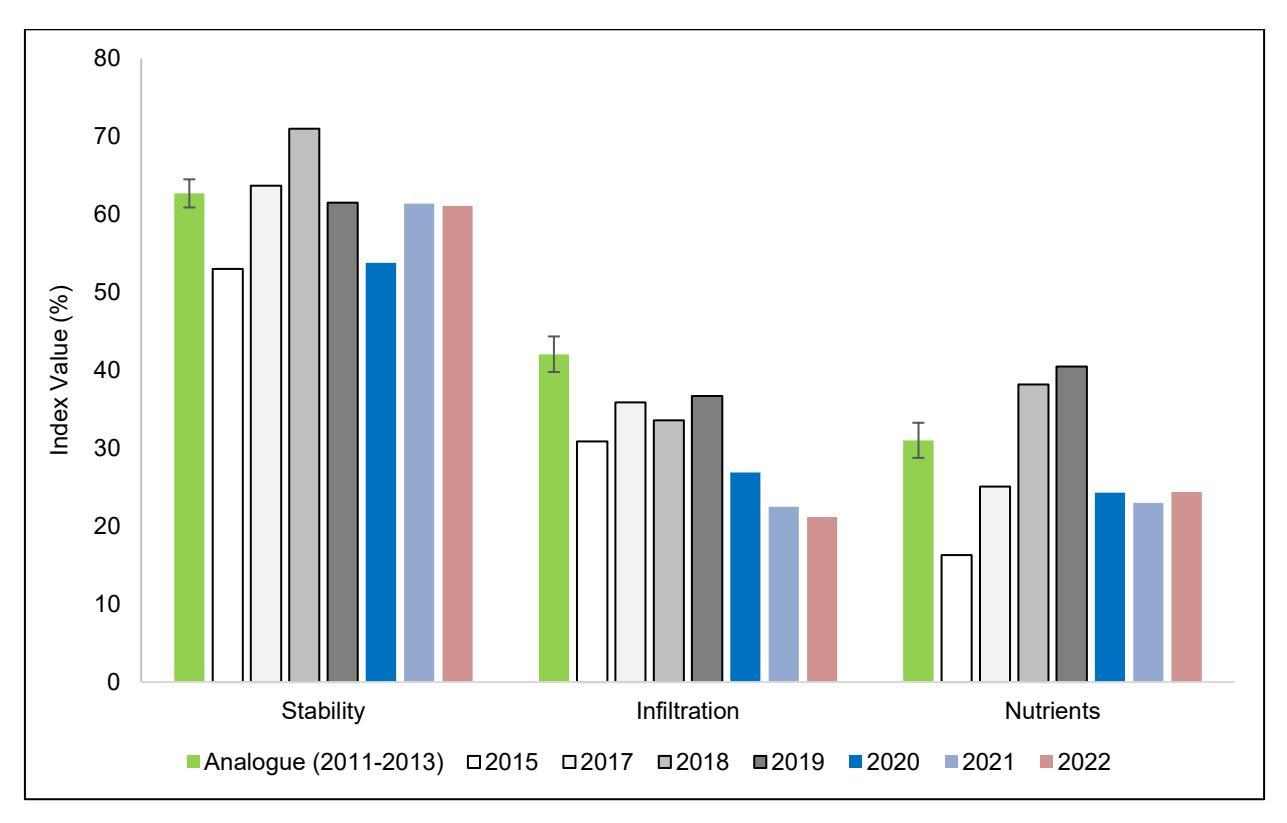
Figure 15. Landscape function indices change (2015-2022) for KANODO RT 07 with respect to mean analogue site values (2011-2013).

At KANODO RT 07 the soil stability index is similar to analogue values while nutrients and infiltration remain lower than the analogue after a high in 2018 and 2019 (Figure 15). The percentage cover of each of the Surface Soil Assessment zones remain similar in 2022, compared to the proportions in 2019-2021, although overall this site has more interpatches and less shrub cover than early assessments of the site. Notably however, a tree patch was present for the first time at this site (Figure 16). Patch sizes have decreased, and inter-patch lengths have increased compared to previous years, leading to a reduction in Landscape Organisational Index away from analogue values (Table 7).

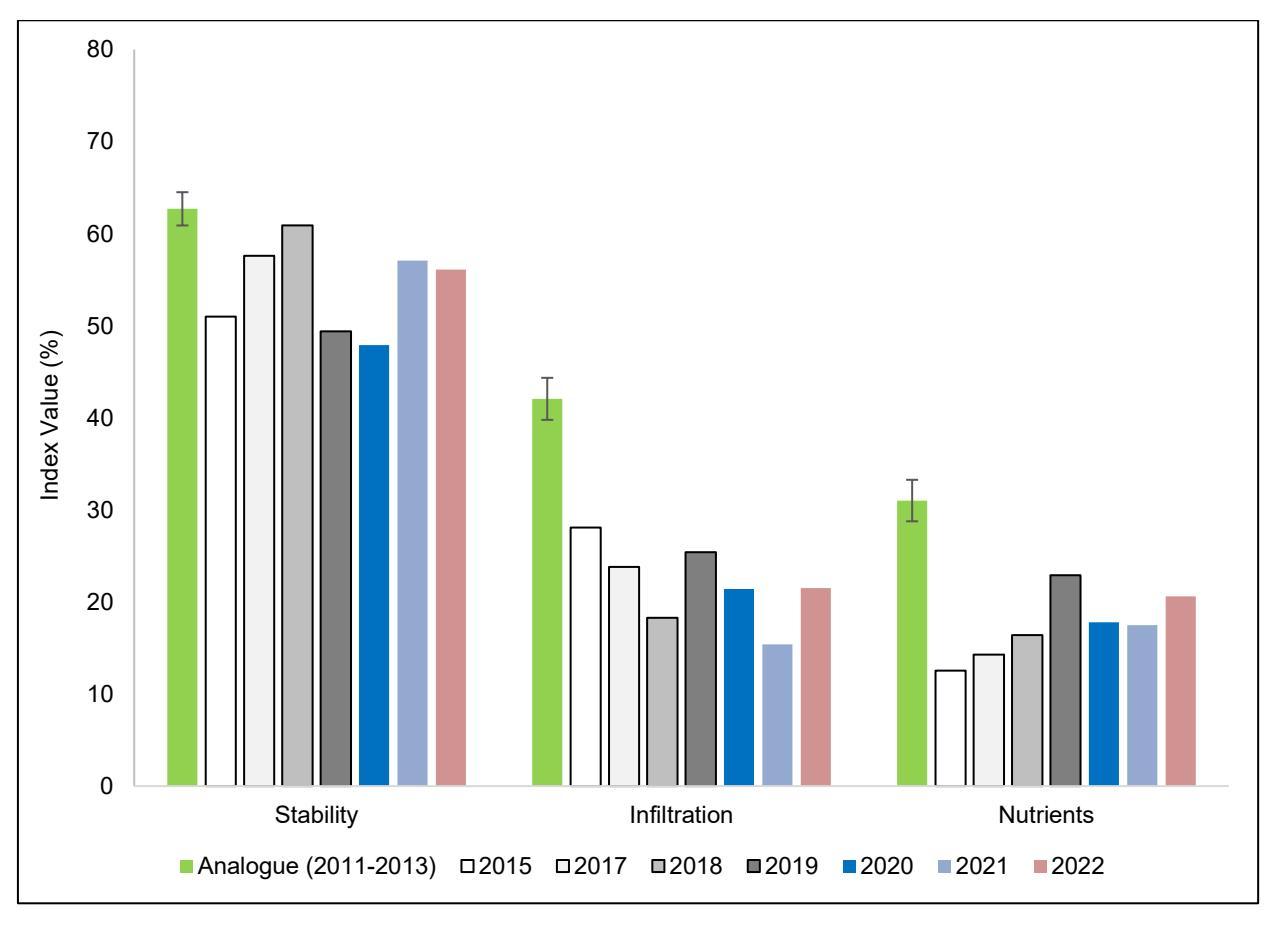
Figure 17. Landscape function indices change (2015-2022) for KANODO RT 10 with respect to mean analogue site values (2011-2013).

KANODO RT 10 remains below mean analogue values for all landscape function indices (Figure 17). Complexity of cover is increasing at the site, with the addition of more tree cover and a reduction in interpatches (Figure 18). Landscape organisational data continues to trend towards analogue values (Table 8).

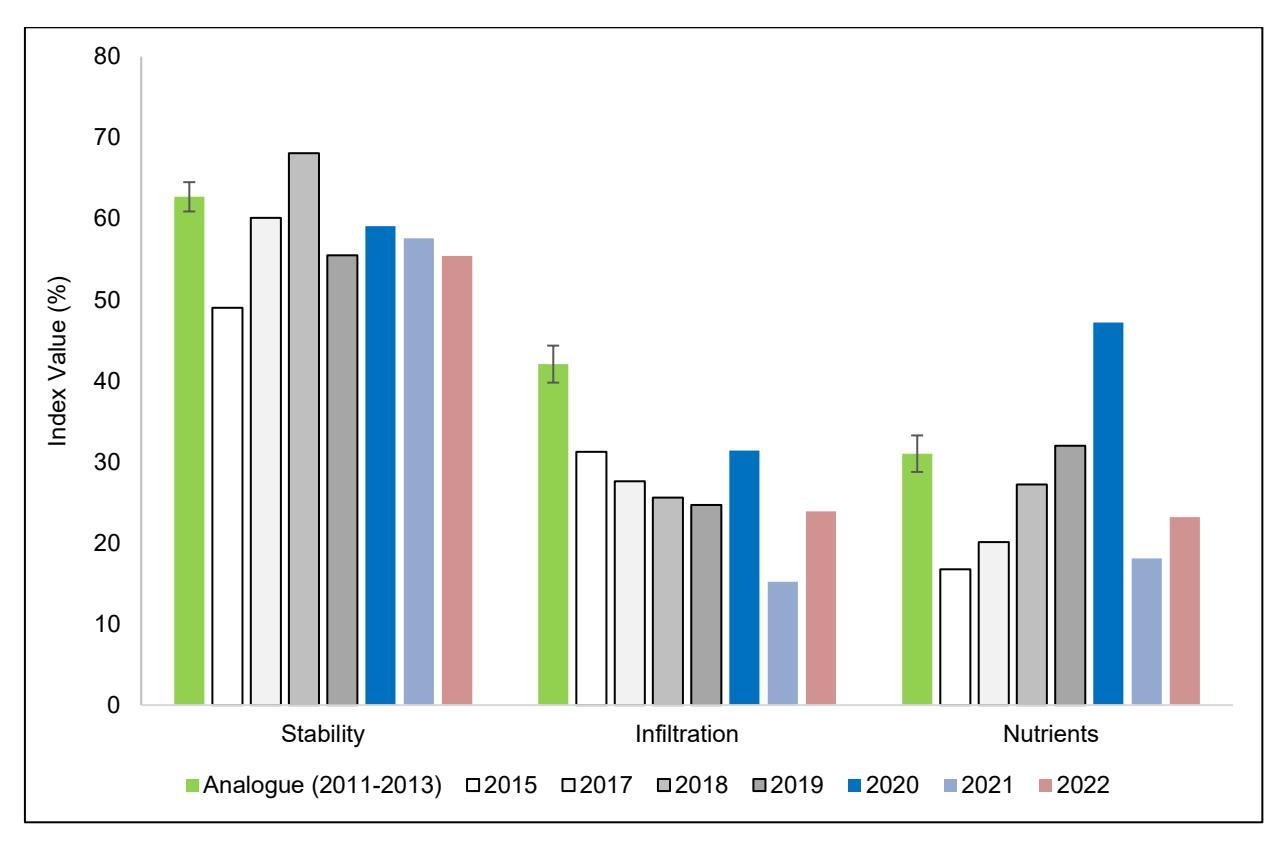
Figure 19 Landscape function indices change (2015-2022) for KANODO RT 12 with respect to mean analogue site values (2011-2013).

The stability landscape function index for KANODO RT 12 is similar to the analogue value, while the infiltration and nutrient indices have increased since last year but are still lower than the analogue values (Figure 19). This could be in part due to a reduction in shrub cover compared previous years (Figure 20) which is also reflected in the low total patch area and landscape organisation index values compared to other years. Landscape organisation values are consistent with observations from 2019 and last year, where low shrub cover was observed, and patches predominantly consisted of interpatches (Table 9).

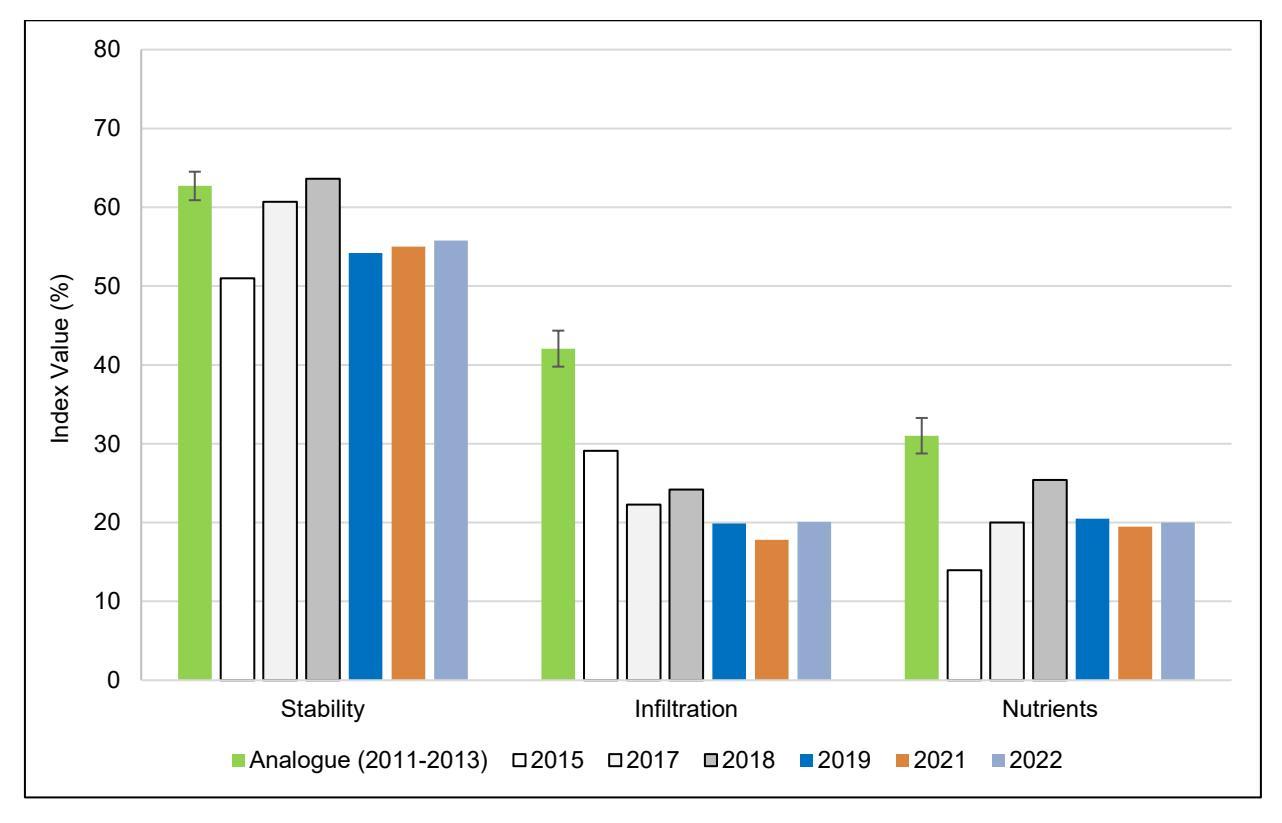
Figure 21. Landscape function indices change (2015-2019 & 2021-2022) for KANODO RT 13 with respect to mean analogue site values (2011-2013).

Landscape function indices recorded at KANODO RT 13 has been similar for the past three survey years but remains lower compared to the analogue values (Figure 21). Interpatch cover remains high, and shrub or shrub grass cover has remained relatively consistent since 2019 (Figure 22). The number of patch zones per 10 m was higher while all other landscape organisation data remains lower than analogue values (Table 10). Visually, the size of shrubs remains similar to previous years (<u>Appendix 3</u>).

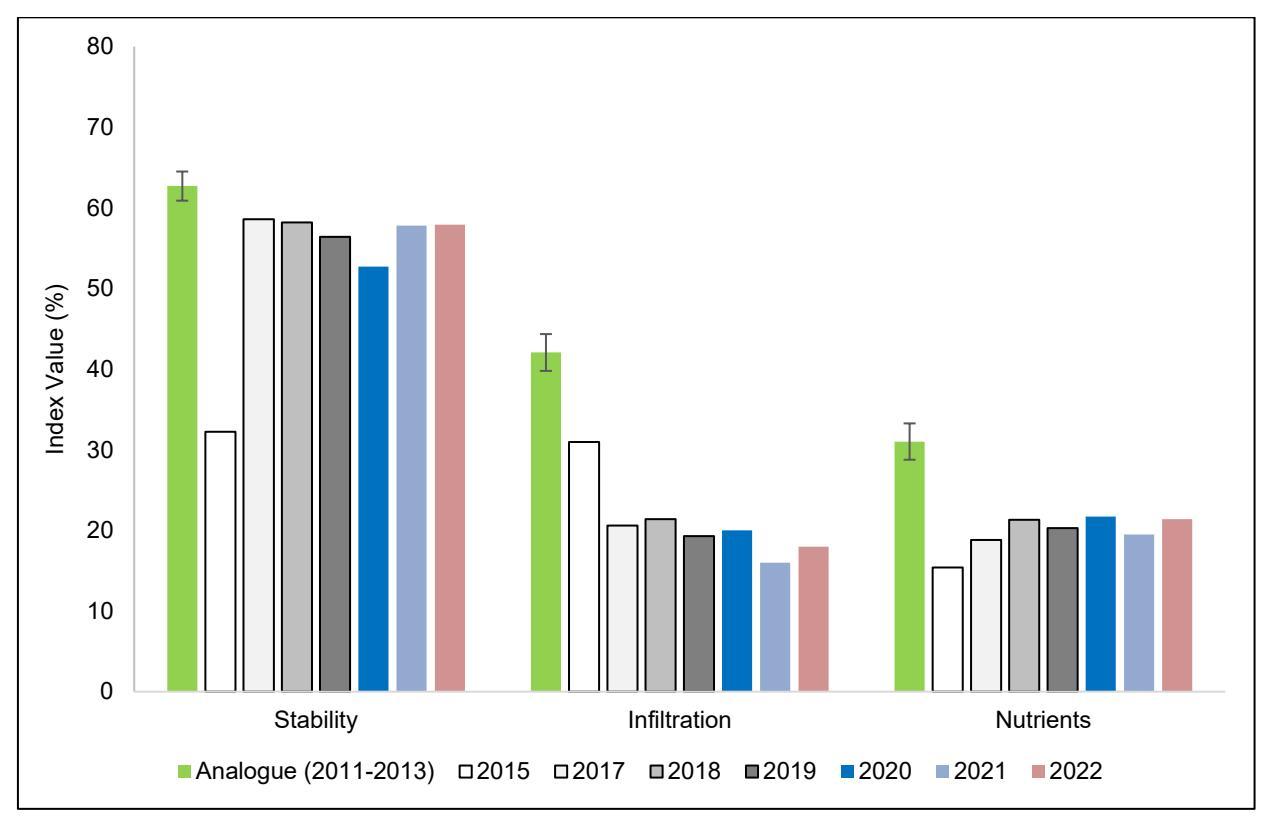
Figure 23. Landscape function indices change (2015-2022) for KANODO RT 14 with respect to mean analogue site values (2011-2013).

KANODO RT 14 showed very similar stability, infiltration and nutrient index values to previous years (2017-2021), of which infiltration and nutrients remain lower than the analogue values (Figure 23). The consistency in indices suggests that this site is stabilising below analogue values. The proportion of shrub and grass cover is very similar to last year's results but has increased compared to 2019 and 2020. An increase in cover complexity is also apparent with the addition of tree cover in the last two survey years (Figure 24). The Landscape Organisational Index for KANODO RT 14 is similar to previous years (Table 11), suggesting the site may not improve towards analogue values under current regimes and may require more intervention to meet target outcomes.

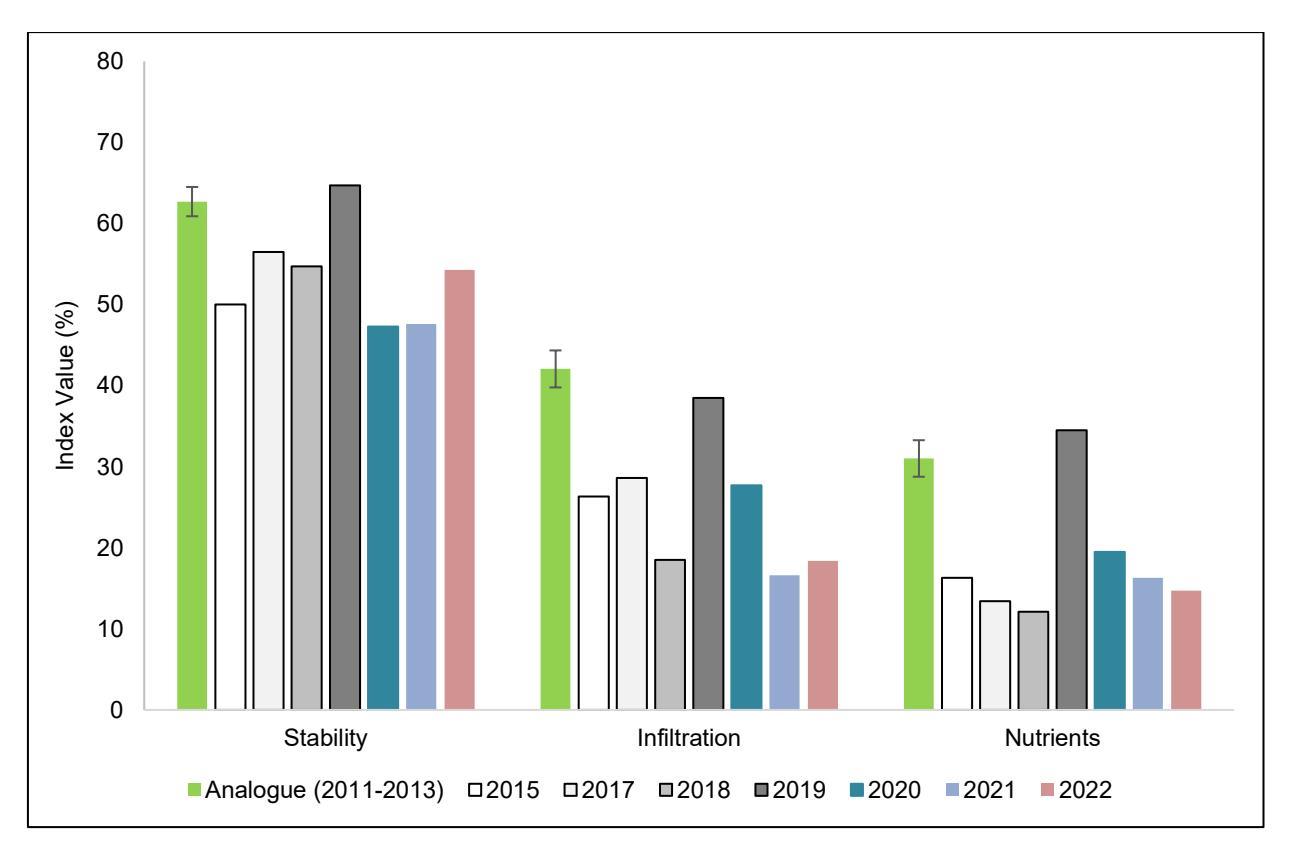
Figure 25. Landscape function indices change (2015-2022) for KANODO RT 15 with respect to mean analogue site values (2011-2013).

Landscape function indices at KANODO RT 15 remain low across all three soil surface indicators at this site (Figure 25). Trough cover has decreased since 2022, while small grass swards have persisted, indicating reduced weathering of the surface is occurring (Figure 26). Additionally, patchiness has decreased to below analogue values suggesting a reduction in the severity of troughs at this site (Table 12). Visually, the site is still predominantly bare ground (Appendix 3).

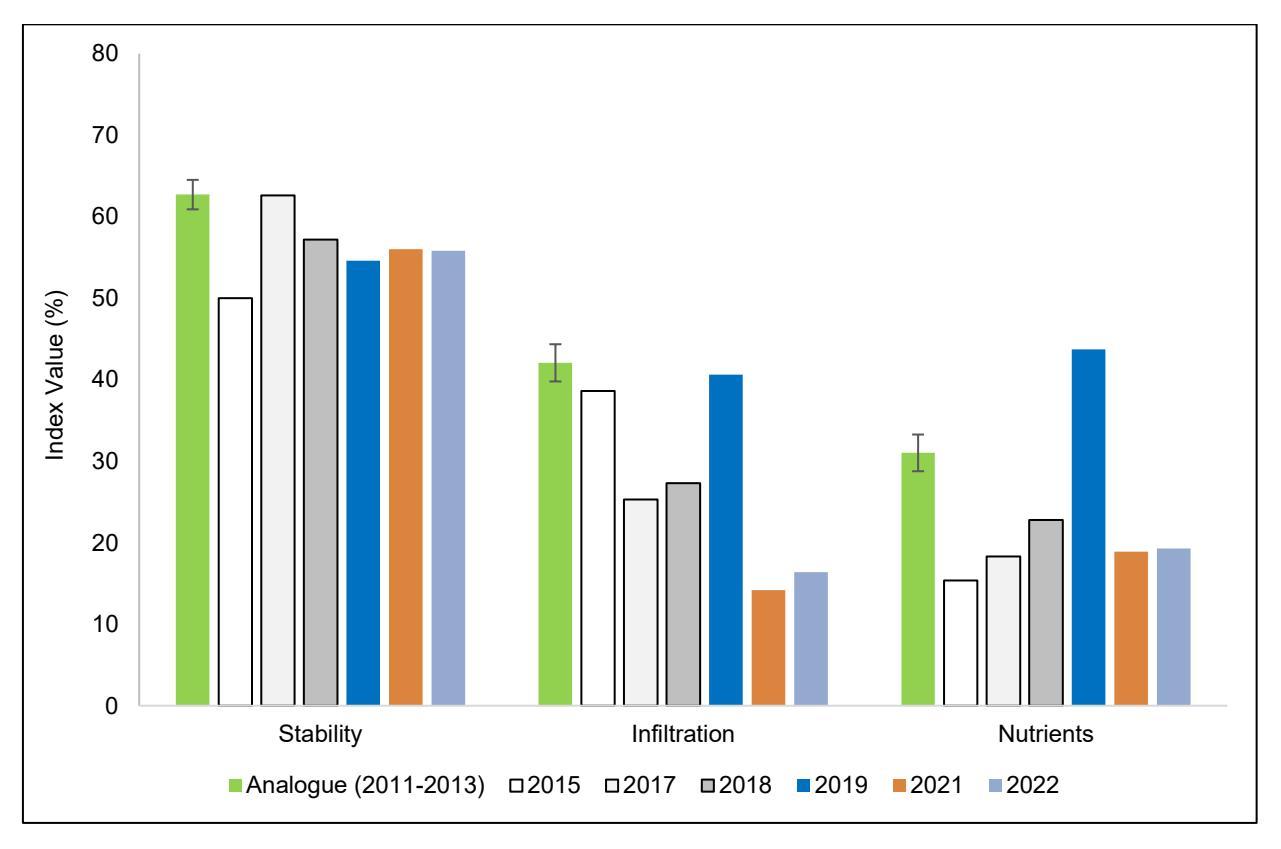
Figure 27. Landscape function indices change (2015-2019, 2021-2022) for KANODO RT 16 with respect to mean analogue site values (2011-2013).

Landscape function indices at KANODO RT 16 were very similar to last year. Stability remained consistent with previous years, but substantial decreases occurred in infiltration and nutrient cycling indices in 2021 compared to 2019, away from analogue values (Figure 27). The interpatch transect proportion was similar to last year and higher than previous years. The site has increased in complexity with the addition of shrubs and shrub grass complexes (Figure 28). Number of patch zones per 10 m has remained higher than analogue values (Table 13) which is likely caused by a reduction in native grass cover (increasing interpatches) after rehabilitation efforts. This change is also reflected visually (Appendix 3).

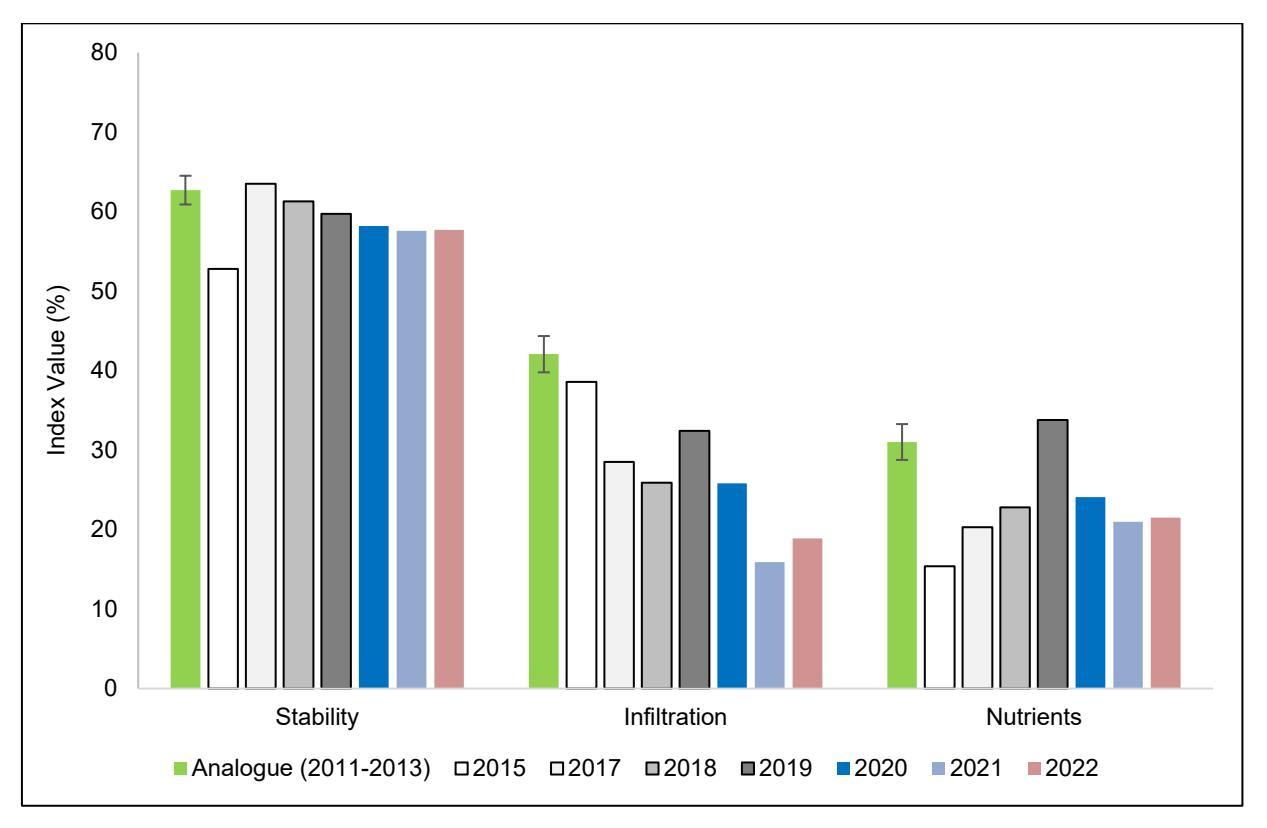
Figure 29. Landscape function indices change (2015-2022) for KANODO RT 17 with respect to mean analogue site values (2011-2013).

Stability and nutrient indices were similar to most previous survey years at this site, while infiltration was lower than all previous years (Figure 29). Infiltration and nutrients remain lower than the analogue values while stability is similar to analogue values. The interpatch cover is high at this site, particularly compared to 2017 and 2018, but the site has increased in complexity with the addition of shrubs to the site (Figure 30). Landscape organisation indices are variable over the survey period, reflecting the decrease in grass cover and fluctuation in shrub cover (Table 14).

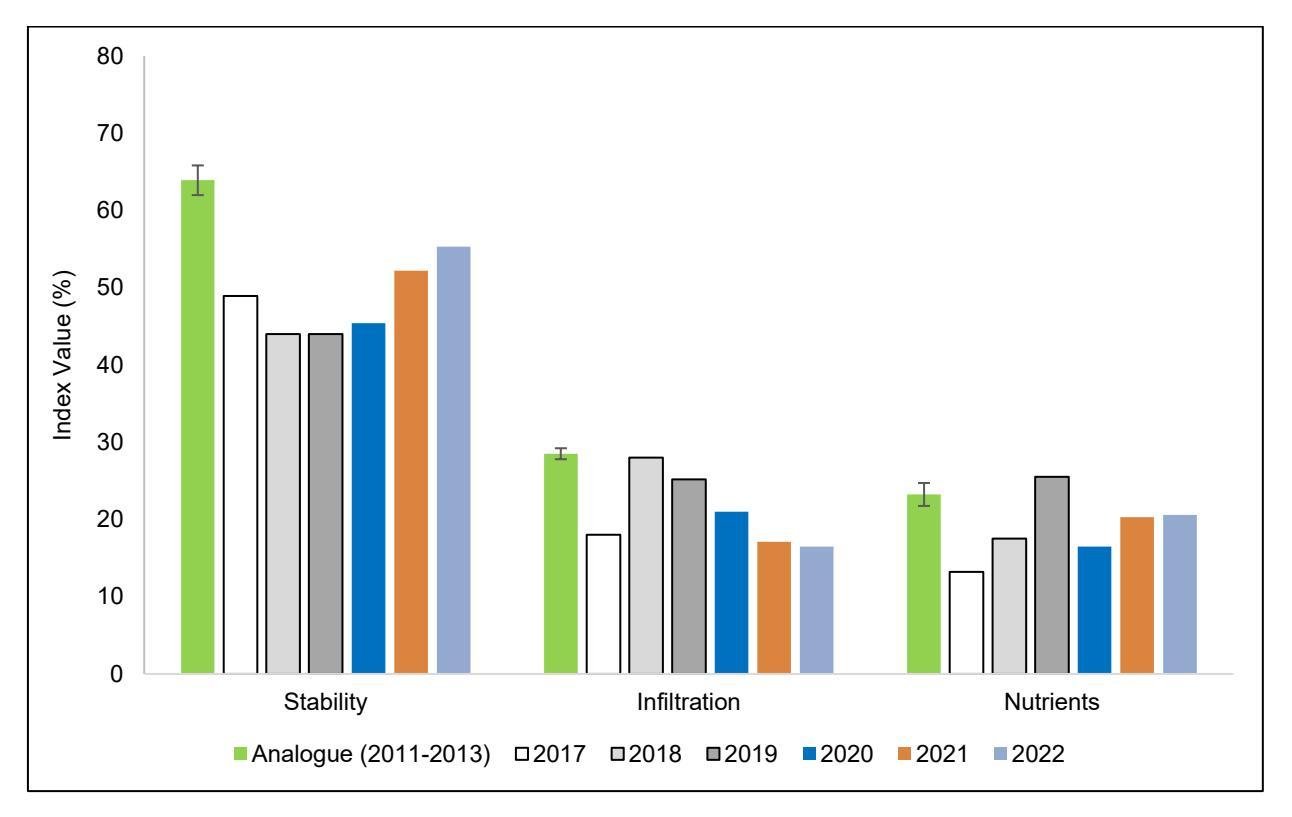
Figure 39. Landscape function indices change (2017-2022) for KANLOM RT 01 with respect to mean analogue site values (2011-2013).

Whilst the stability value of KANLOM RT 01 has slightly increased from previous years, all index values remain lower than analogue values (Figure 39). The percent cover of troughs has been variable across surveys, likely a result of surveyor interpretation, and there are now discrete shrub patches (Figure 40). The Landscape Organisational data is variable over the years, as this site is still within early stages of rehabilitation. The number of patch zones per 10 m is higher than analogue values, reflective of the complexity of cover (Table 19).

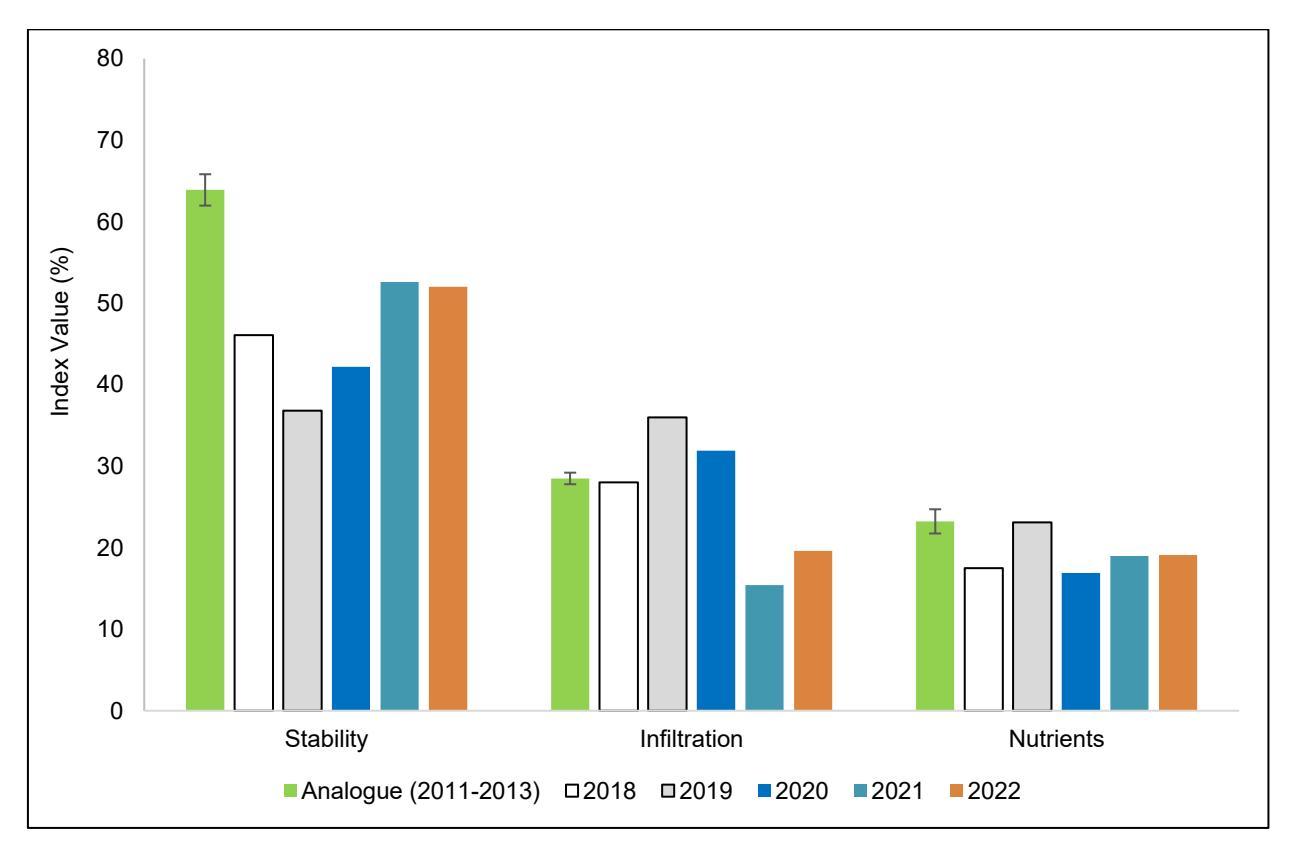
Figure 41. Landscape function indices change (2018-2022) for KANLOM RT 02 with respect to mean analogue site values (2011-2013).

The current landscape function indices for KANLOM RT 02 remain below the analogue, likely due to the physical properties of the soil within this area. The infiltration value has increased since last year but is lower than all other previous years and the analogue values, suggesting soil roughness and soil surface resistance to disturbance had decreased (Figure 41). Grass swards have established within the troughs, leading to the reduction in proportion of trough compared to grass from the past three survey years (Figure 42). The reduction in shrubs and shrub grasses has resulted in the percentage cover approaching analogue values. Most Landscape Organisational Indices are approaching analogue values, except the number of patches per 10 m which is an indicator of increasing complexity and more grasses growing in troughs (Table 20).

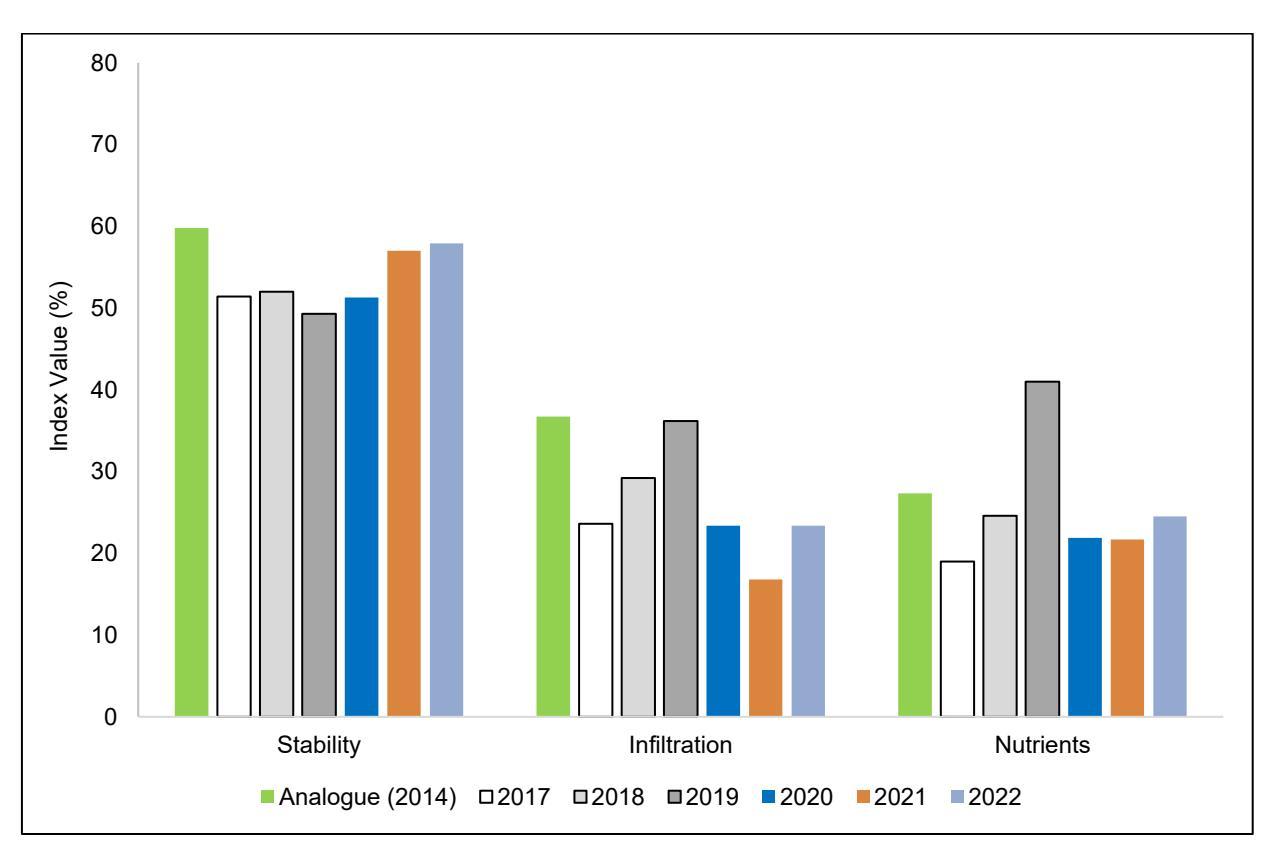
Figure 43. Landscape function indices change (2017-2022) for KANACA RT 01 with respect to mean analogue site values (2014).

The soil stability and nutrient values at KANACA RT 01 are similar to previous years, slightly below analogue values, whilst infiltration values have increased compared to the previous survey year (Figure 43). Both grass sward cover and shrub cover have decreased from previous years and away from analogue values, while tree and tree grass patches were observed for the first time (Figure 44). Patch zones are yet to stabilize as the vegetation continues to develop and transform through early successional stages. The number of patch zones per 10 m is high, reflective of the complexity of cover (Table 21). Additionally, one *Caladenia verrucosa* (Yellow-club Spider-orchid) was observed on this rehabilitation transect (Figure 45). Presumably seed from this species was in the soil and has successfully germinated this monitoring year.

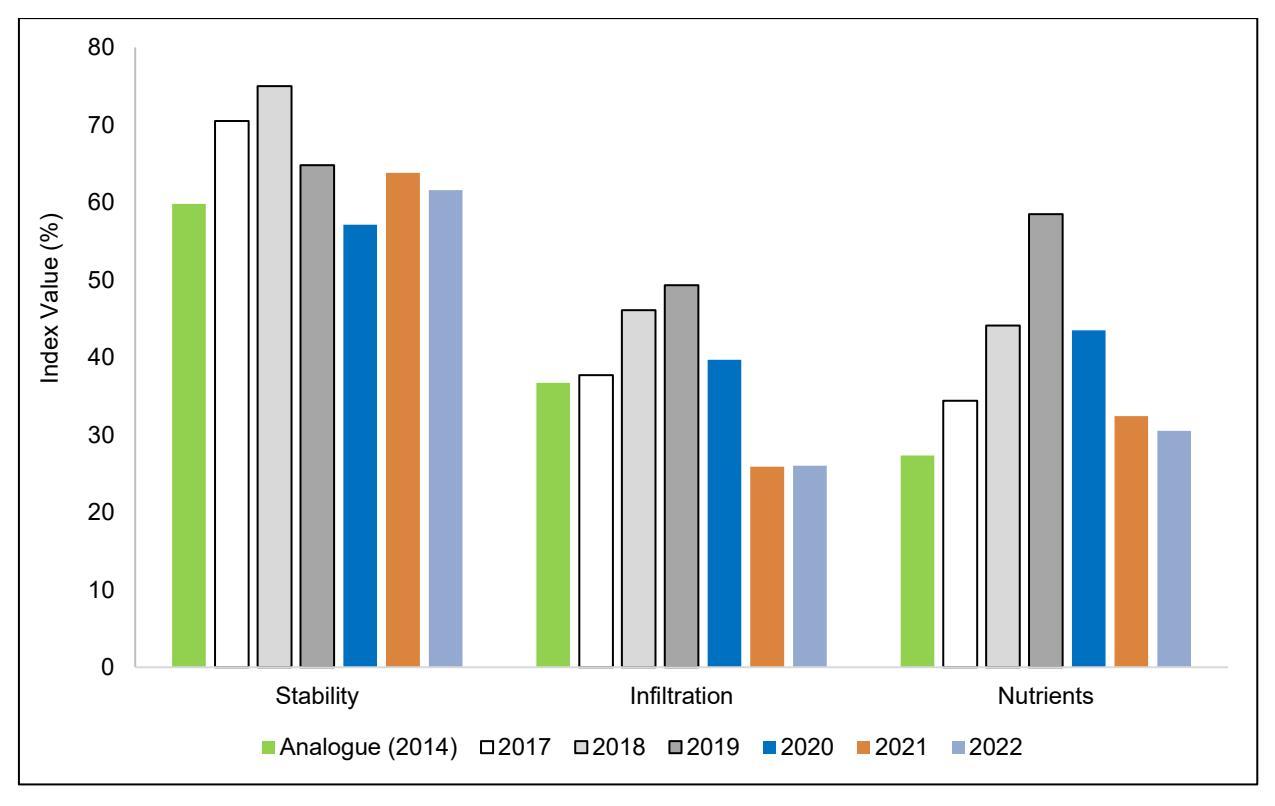
Figure 46. Landscape function indices change (2017-2022) for KANACA RT 02 with respect to mean analogue site values (2014).

The sixth year of monitoring KANACA RT 02 has seen a decrease in infiltration and nutrient values compared to previous years, although nutrient values are still above analogue values (Figure 46). After initial uniform grass sward cover over the first three years (2017, 2018 & 2019), interpatches have increased and trees have established at the site (Figure 47). Increasing patchiness in grass cover at the site has resulted in the number of patches per 10 m being greater than analogue results. Total patch area has increased while average interpatch length and landscape organisational index remain similar compared to last year (Table 22).
