# Kanmantoo Copper Mine Landscape Function Analysis 2022

30 January 2023

## Prepared by EBS Ecology for Hillgrove Resources Limited

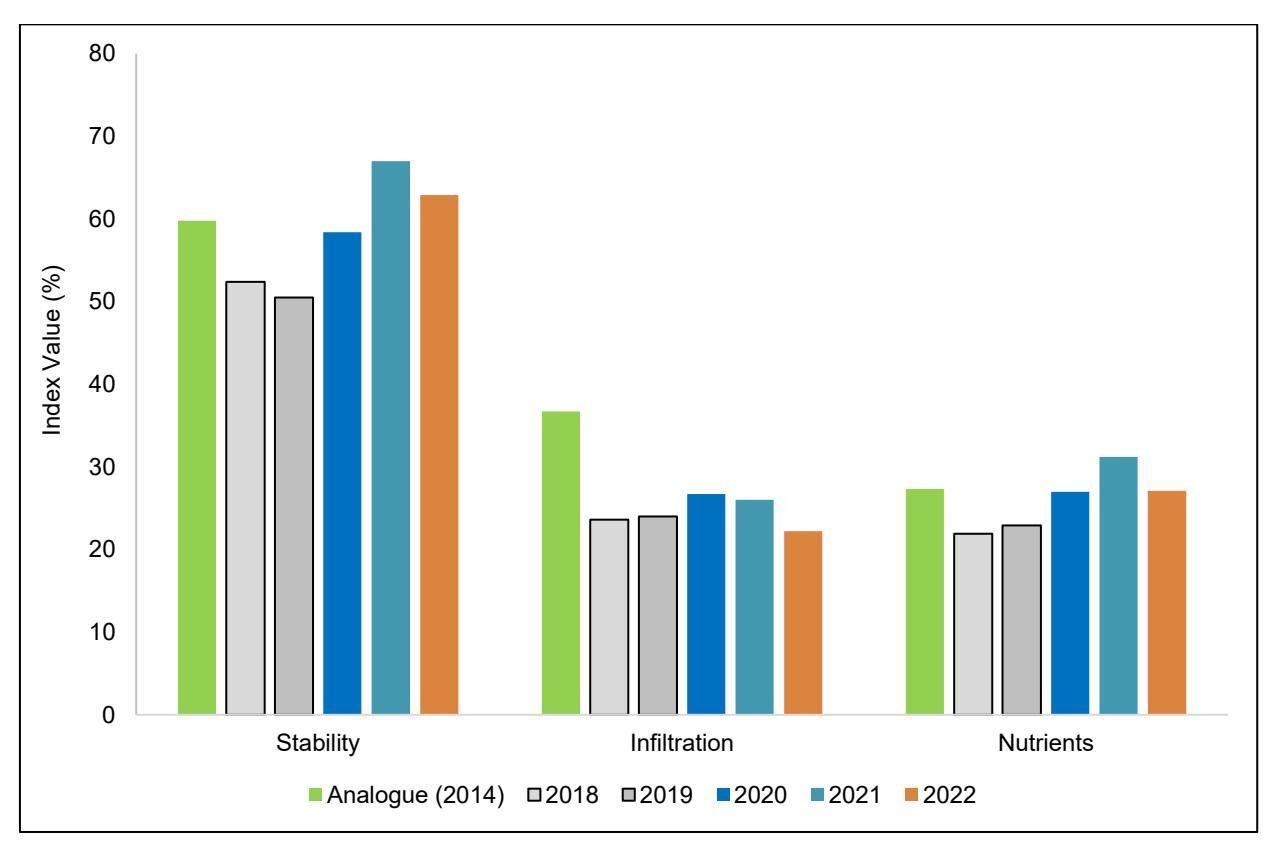
Figure 48. Landscape function indices change (2017-2022) for KANACA RT 03 with respect to mean analogue site values (2014).

In the fifth monitoring year for KANACA RT 03, stability and nutrient values are very similar to analogue values, while infiltration remained similar to previous years (and below analogue values) (Figure 48). The site was showing some increase in complexity with the addition of shrub cover in 2021 but this cover was absent in the 2022 monitoring year (Figure 49). The landscape organisational indices across the six years are variable as the vegetation continues to develop and transform through early successional stages (Table 23).

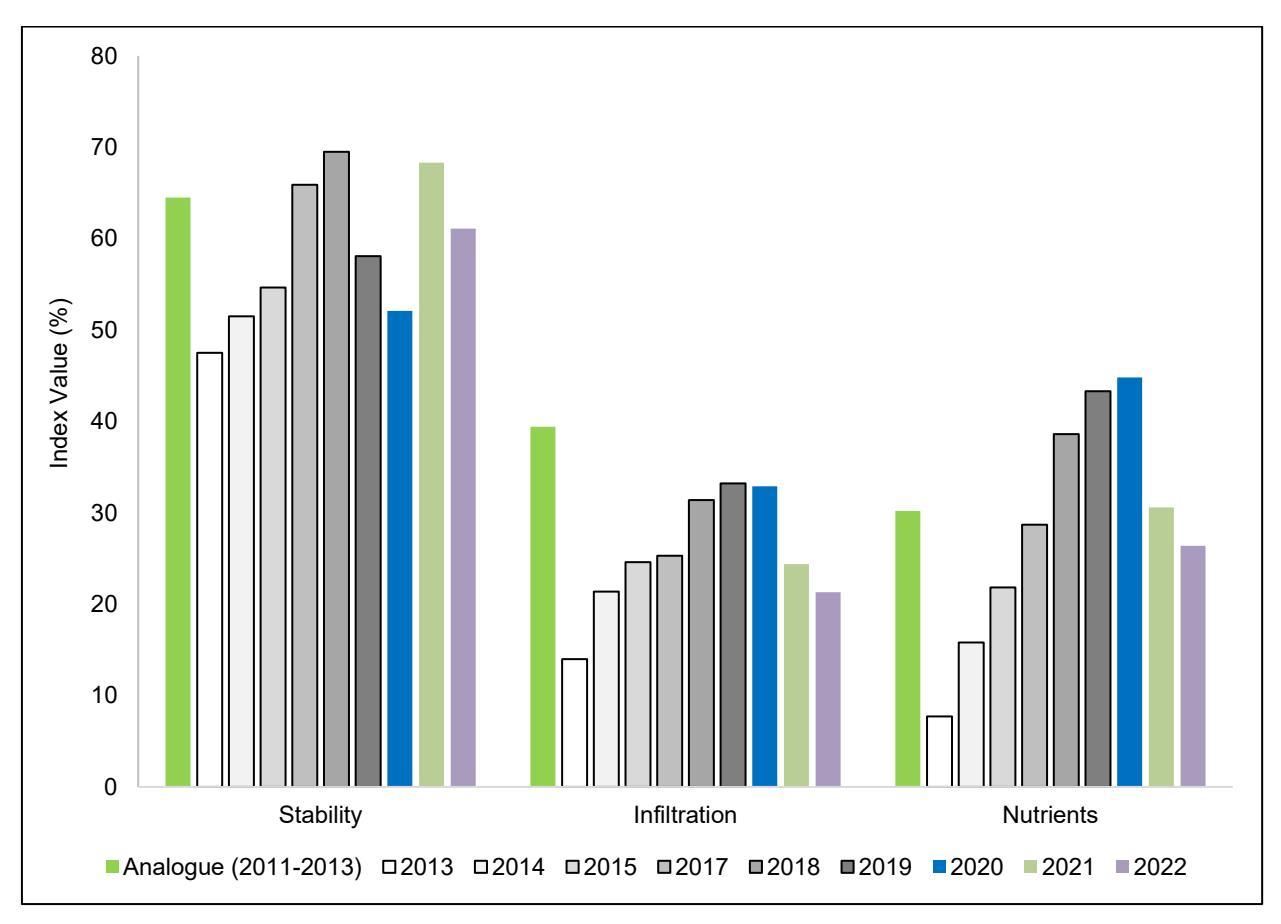
Figure 50. Landscape function indices change (2013-2022) for KANGRA RT 01 with respect to mean analogue site values (2011-2013).

The permanent grass laydown area established in 2012 now has a good cover of *Chloris truncata* (Windmill Grass) which was the original species planted. Infiltration and nutrient function indices have decreased over the past two monitoring years while stability has decreased since last year with all indices lower than analogue values (Figure 50).
