# Kanmantoo Copper Mine Landscape Function Analysis 2022

30 January 2023

## Prepared by EBS Ecology for Hillgrove Resources Limited

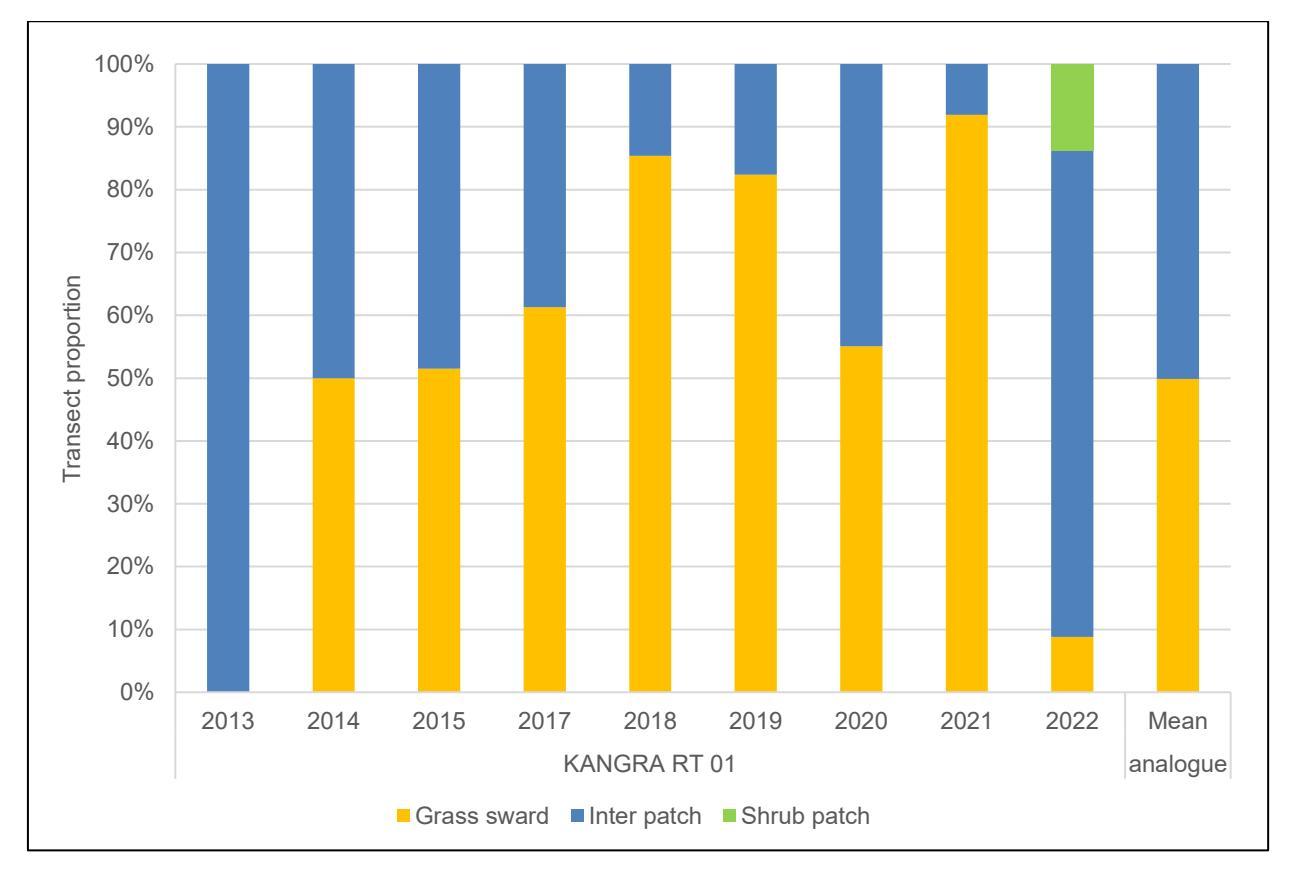
Figure 51. Percentage cover of each of the Surface Soil Assessment zones recorded at site KANGRA RT 01.

The proportion of grass sward has decreased while the proportion of interpatches has increased at this site. Shrub patches have been observed for the first time at this site (Figure 51). Landscape organisation indices remain variable due to the dynamic nature of early revegetated areas (Table 24).

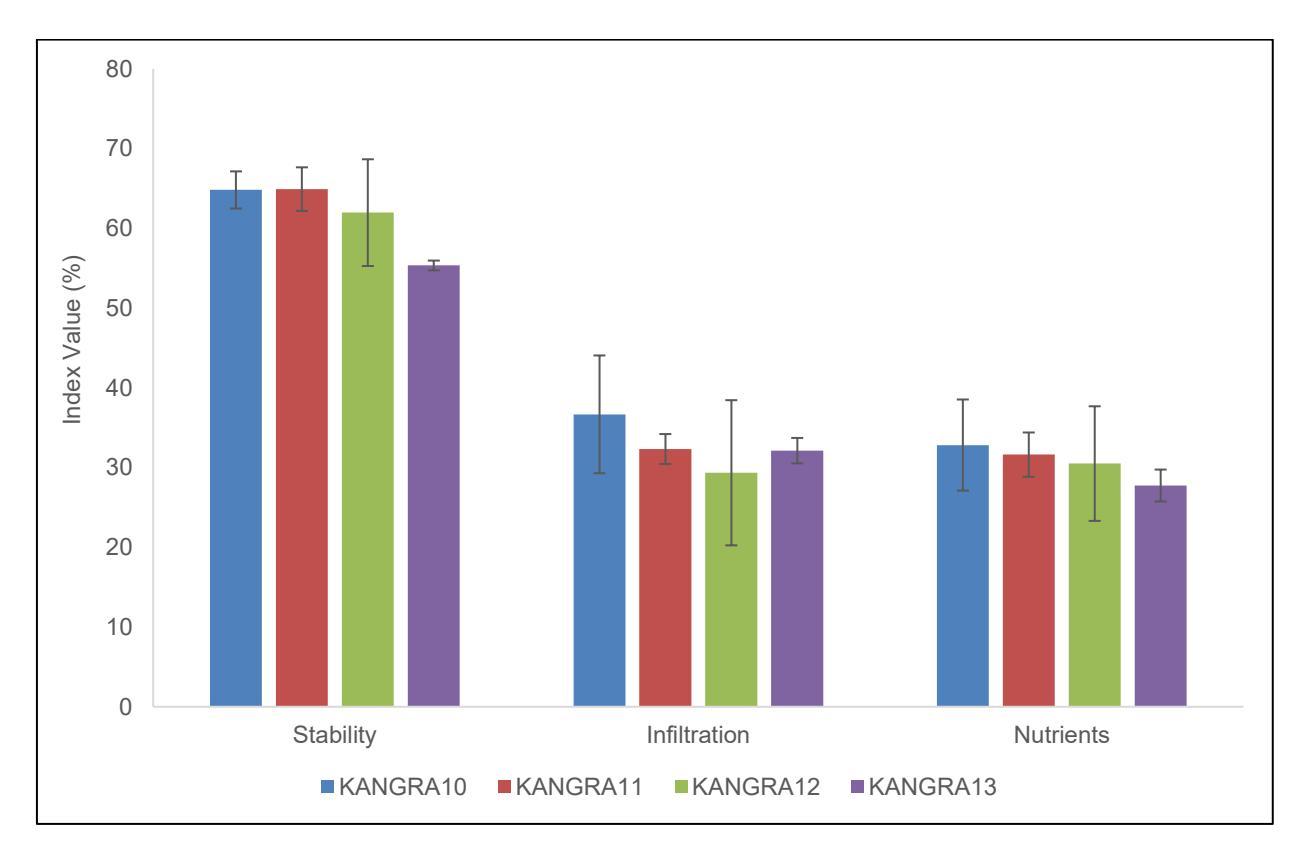
Figure 52. Average Landscape function indices from 2019 to 2022 for the four analogue grassland sites KANGRA 10-13.

The average soil surface indicators were generally similar across all four sites with lower stability and nutrients for KANGRA 13 compared with the other three sites (Figure 52). Average vegetation cover proportions were also similar across sites, with sedge patch and rock grass complex a feature in only KANGRA 11 (Figure 53). Landscape organisational indexes for all four sites differ substantially from 2021 values (Table 25; Table 26; Table 27 and Table 28). Compared to the largely uniform native grasslands of 2019, it appears that annual exotic grasses had benefitted greatly with above average rainfall in the last three years, leading to much greater inter-patches compared to grass swards. This is why it is important to have multiple years of data for analogue sites, in order to lessen the effects of yearly fluctuations on data from stochastic factors such as weather.
